Environmental Durability and Stress Rupture of EBC/CMCs

Matthew Appleby, Dr. Gregory N. Morscher – Department of Mechanical Engineering, The University of Akron, Akron, OH
Dr. Dongming Zhu - Durability and Protective Coatings Branch, NASA Glenn Research Center, Cleveland, OH

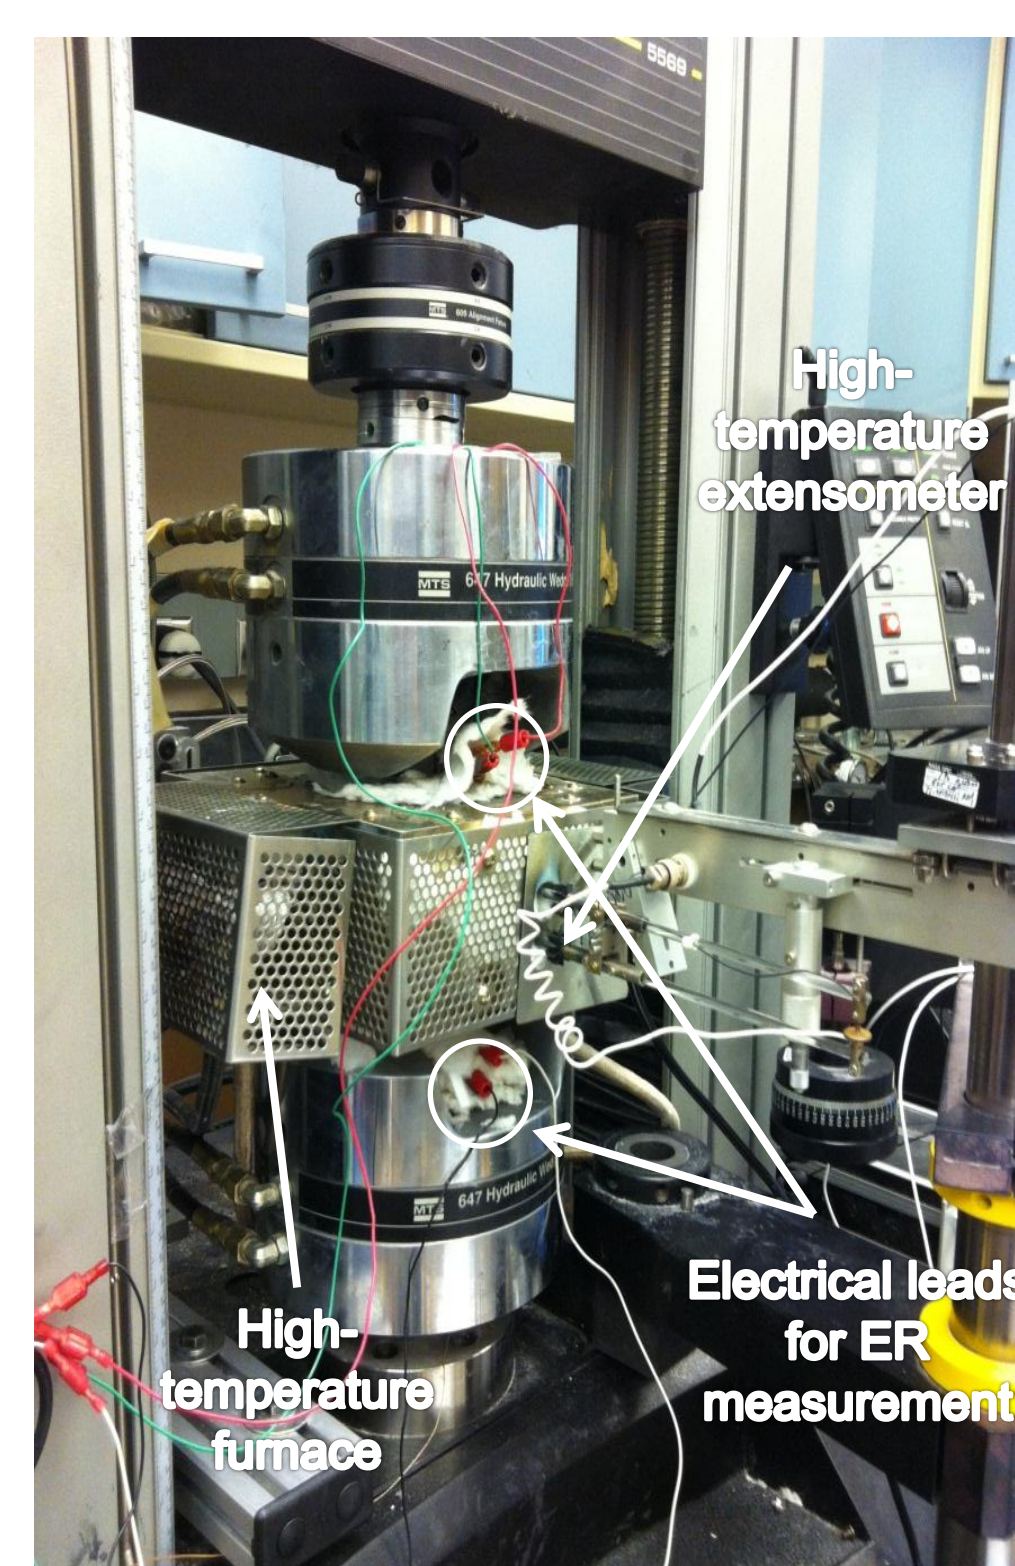
Isothermal Creep Characterization

- Isothermal Tensile Creep tests are widely used methods for characterizing life limiting viscoelastic behavior and investigating the relationship b/t creep strain and external variables.

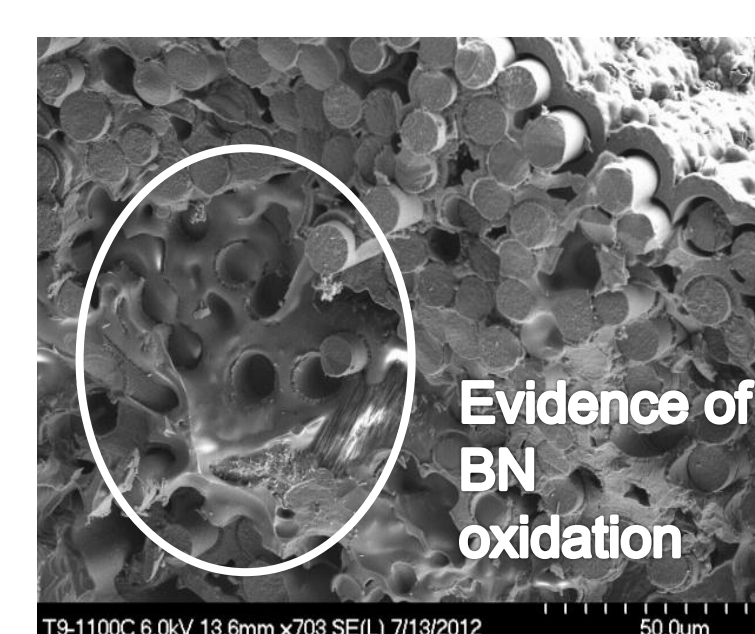
- Stress rupture without the influence of stress/temperature gradients, and harsh environmental exposures

T = 1100°C
σ = 103 MPa
t = 480 hr

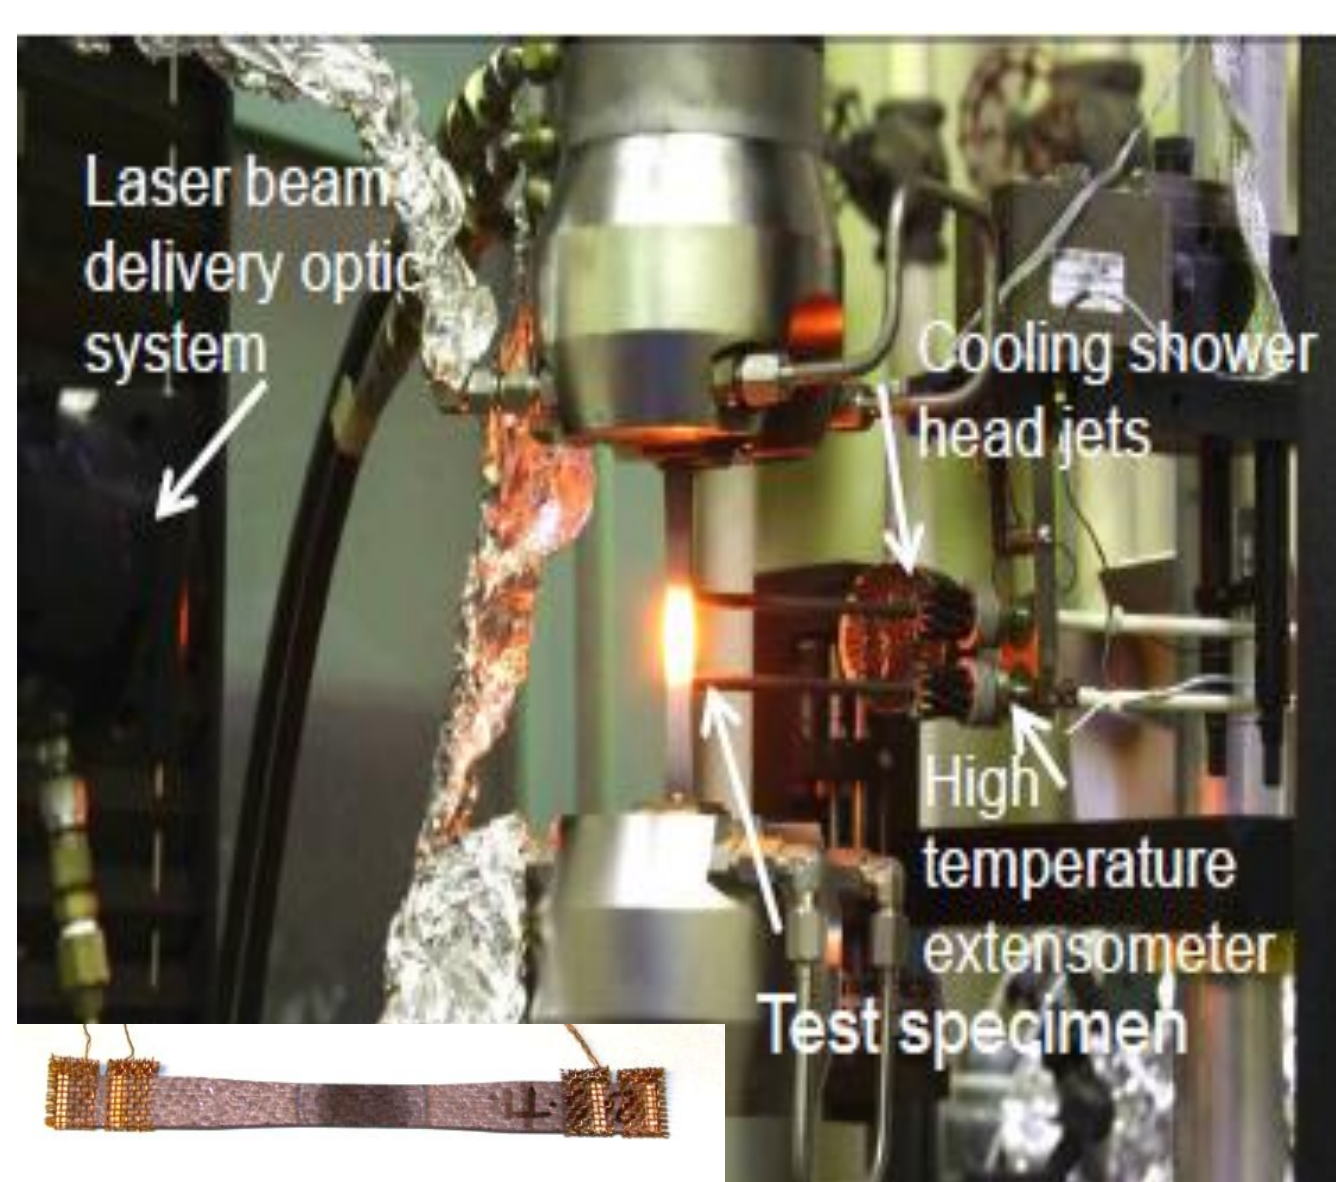
Laser Based High Heat Flux Tensile Testing

- Laser induced Thermal Gradient Tensile tests combine high heat flux with thermo-mechanical loading conditions.

- In-situ **Electrical Resistivity (ER)** monitoring incorporated to assess material damage state
- Transverse matrix crack development and fibers strains/breaks limit the flow of current; increasing the overall resistance.
